DATE: March 6, 2001

SUBJ: Ball Trap Fix @ Bottom Bumper

Stern[™] Pinball, Inc. © 2001 Technical Service Bulletin Nº 123 Want Service Bulletins by eMail? click Parts.Service@SternPinball.com

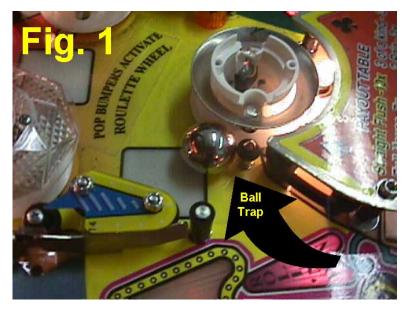
Ball trap at the Bottom Bumper (See Fig. 1). Indication is a high number in Audit 35, Ball Search Started or Customer Complaints.

The **Post** by the **Bottom Bumper**, which was added to increase *Bumper Action*, created a **Ball Trap** if the Post was positioned slightly away from the Bumper. Removing the Post to a slightly better position is Not Recommended as the new position's resulting hole would be too close to the original hole which would not hold the Post.
