DATE: April 19, 2001

SUBJ: Quick Tip for Display Troubleshooting:

U201 White Star Board System™

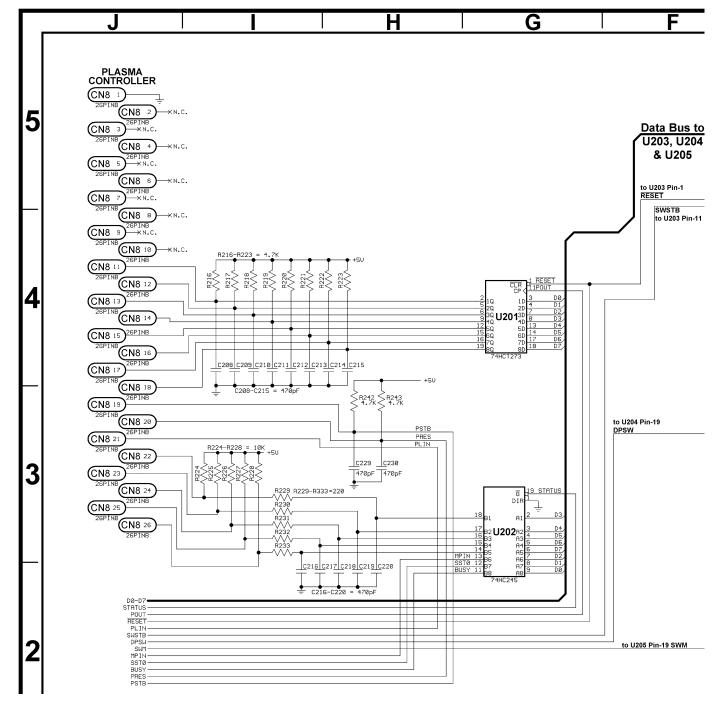
CPU/Sound Board Schematic (Sheet 3 of 3)

U201 Failed. U201 is a 74HCT273 Data Latch (see the CPU Sound Bd. pictorial, lower right).

Plasma Interface: The data path for communication to and from the Plasma Controller Board is 8 bits wide. There are separate *Input* and *Output Busses*. The *Input Bus* from the Plasma Controller to the CPU/Sound Board comes in on CN8 [PLASMA CONTROL]-Pins 3-10 and is fed into U200 for input to the CPU's *Data Bus*. Data going out to the controller comes from the CPU's *Data Bus* through U201 and onto CN8-Pins 11-18. Status back from the Plasma Controller comes in on CN8-Pins 22-26 and is fed into U202 for input to the CPU's *Data Bus*. Two control signals that go out to the Plasma Controller are PRES [PLASMA RESET] and CN8-Pin 19 [PSTB - Plasma Strobe]. The Plasma Reset is software controllable through U216/B and also has a test point "Plasma Reset". The *Plasma Strobe Signal* to the controller is generated from U216/A and is *used to latch data* into the Plasma Controller.

Replace U201.
