Nº 127 SERVICE BULLETIN

SUBJ: Plastic Stadium Flashlamp Removal

STRIKER XTREME &

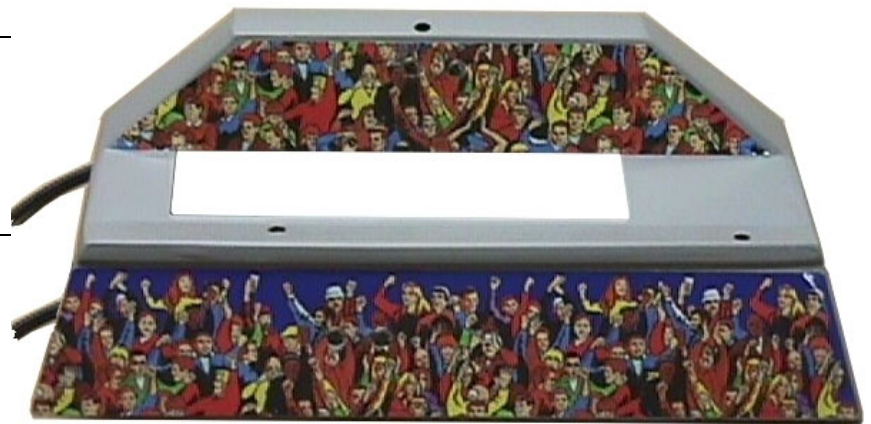
Fig. 1

The Stadium Plastic Cover (**Fig. 1**) begins to *distort and/or melt* at the top from heat build-up (generated by the flashlamps).

We have received a few calls from distributors and operators complaining that the Stadium Plastic Cover is becoming damaged from the heat generated from the flashlamps inside. The **top two** (2) flashlamps (*which are riveted inside of the assembly*) may move due to vibration depending on how snug the rivet is. When the bulbs move too close to the inside surface of the stadium, *they may cause heat damage*. As the material softens over time, the plastic may distort (or melt).
