Nº 131 SERVICE BULLETIN

DATE: January 23, 2002

SUBJ: Electric Company Sign / Backbox J2 Harness Re-dress

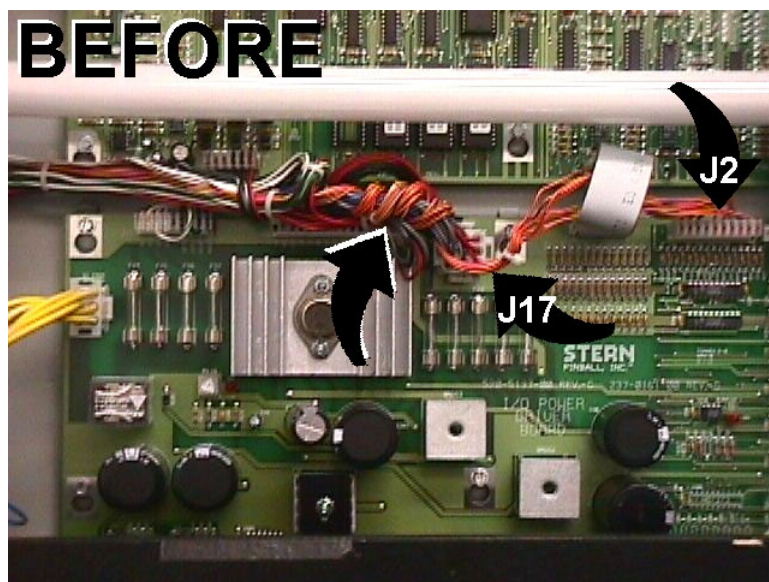
The **J2 Harness** that carries the data from the I/O Bd. to the Electric Co. Sign has been dressed in such a way that it is picking up electrical noise/surges from the **J17 A.C. Harness**. This harness is used to supply the A.C. voltages to the I/O Board from the secondary of the transformer. See the "**BEFORE**" picture of the I/O Board which shows the **J2 Harness** wrapped around the **J17 Harness**. If left alone (wires wrapped around J17 harness), it could cause damage to the I/O Board or the Electric Company Sign.

Electric Company Sign shows garbled information.

I.C.'s **U201** and/or **U206** have failed on the I/O Power Driver Board.
