**SERVICE BULLETIN 1A
(Reprint)**

FROM: Pete Gustafson, Field Service Mgr.
TO: Service Managers
DATE: April 12, 1988
RE: Secret Service - Cross Playfield Plunger Shot

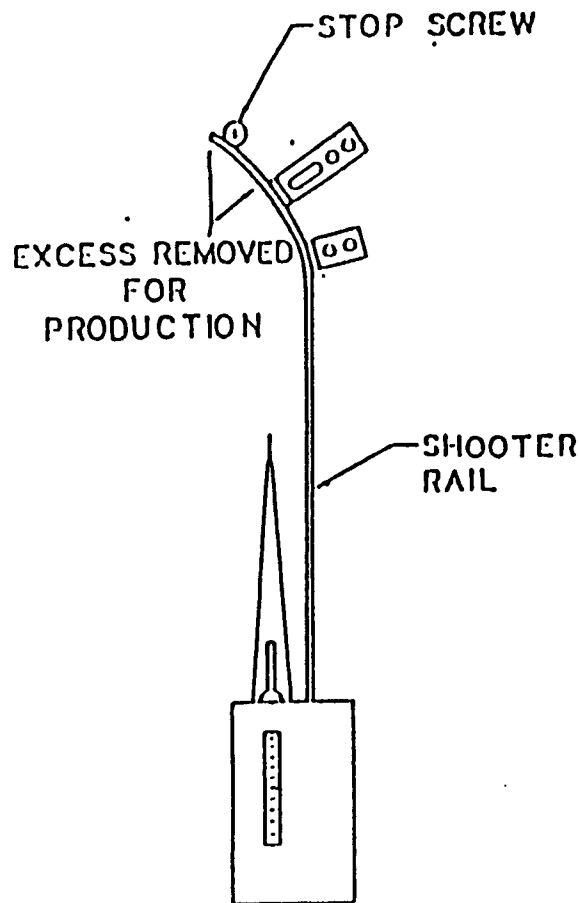
FIG. 1

1. The cross playfield shot from the ball shooter is adjustable, but may require premature adjusting due to the excessive length of the shooter ball rail. We have added a hole to the adjustable rail mounting bracket and the rail has been shortened (shown in Fig. 1) for the remainder of production but a stop screw should be installed behind the rail once it is adjusted properly.

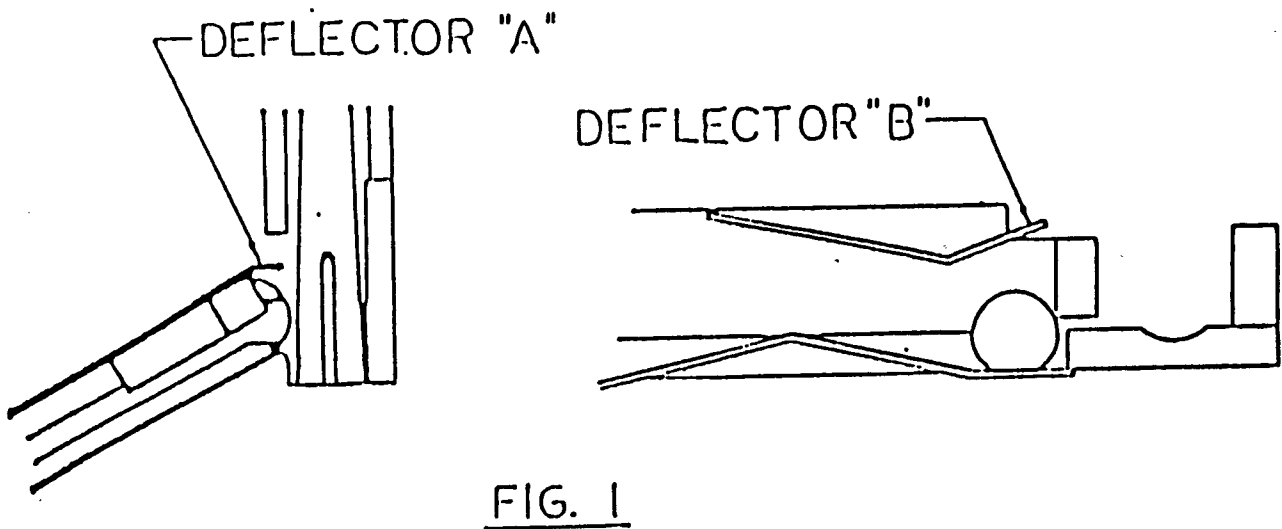
2. The ball trough eject may require adjustment due to the ball being kicked into the shooter lane and deflecting back into the trough without reclosing the first trough switch. The adjustable deflection plate shown in Fig. 1 must deflect the ball down and to the rear to correct this problem. Adjust deflector "A" to the rear until the ball slightly deflects off the plate. Adjust deflector "B" downward for the same effect.
