Service Bulletin #24

To: Service Manager
 From: Data East Pinball Service
 Date: March 22, 1990
 Subject: Weak Ball Trough Ejects

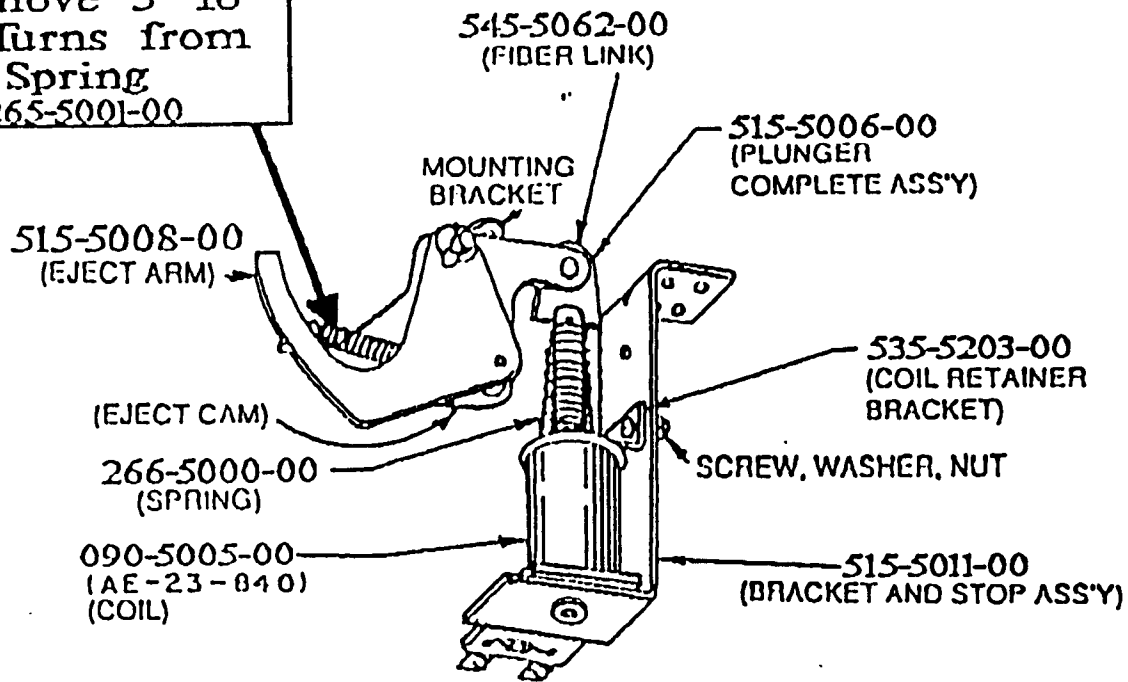
500-5012-00 BALL FEED ASSY

Symptom: The ball is ejected into the shooter lane with very little strength. Sometimes it will not make it into the shooter lane.

Problem: The ball trough eject cam is not striking the ball in ball center or the cam shock absorbing spring is too weak.

Solution: Lift the playfield and examine the point at which the ball is being struck by the cam. If it is not striking the ball in its center, bend the cam by hand until it does. Play a game to see if the ball trough eject is working properly. (It should push a ball with enough force to cause it to strike the right side shooter lane wood rail.) If it does not, do the following:

- With a needle nose pliers, remove the spring from the stud as indicated in the diagram.
- Using your needle nose pliers put one tip of the pliers down the throat of the spring between 5-8 turns and bend the spring at that point 90 degrees.
- With a pair of side cutters, remove the bent over turns leaving one loop to reattach the spring to the stud with.
- Using the needle nose pliers reattach the spring to the stud being careful not to stretch the spring out of its shape.

Remove 5 To
10 Turns from
Spring
265-5001-00
