**SERVICE BULLETIN 36
(Reprint)**

FROM: Field Service Dept., Data East Pinball, Inc.

DATE: July 20, 1992

RE: Lethal Weapon 3 Flippers

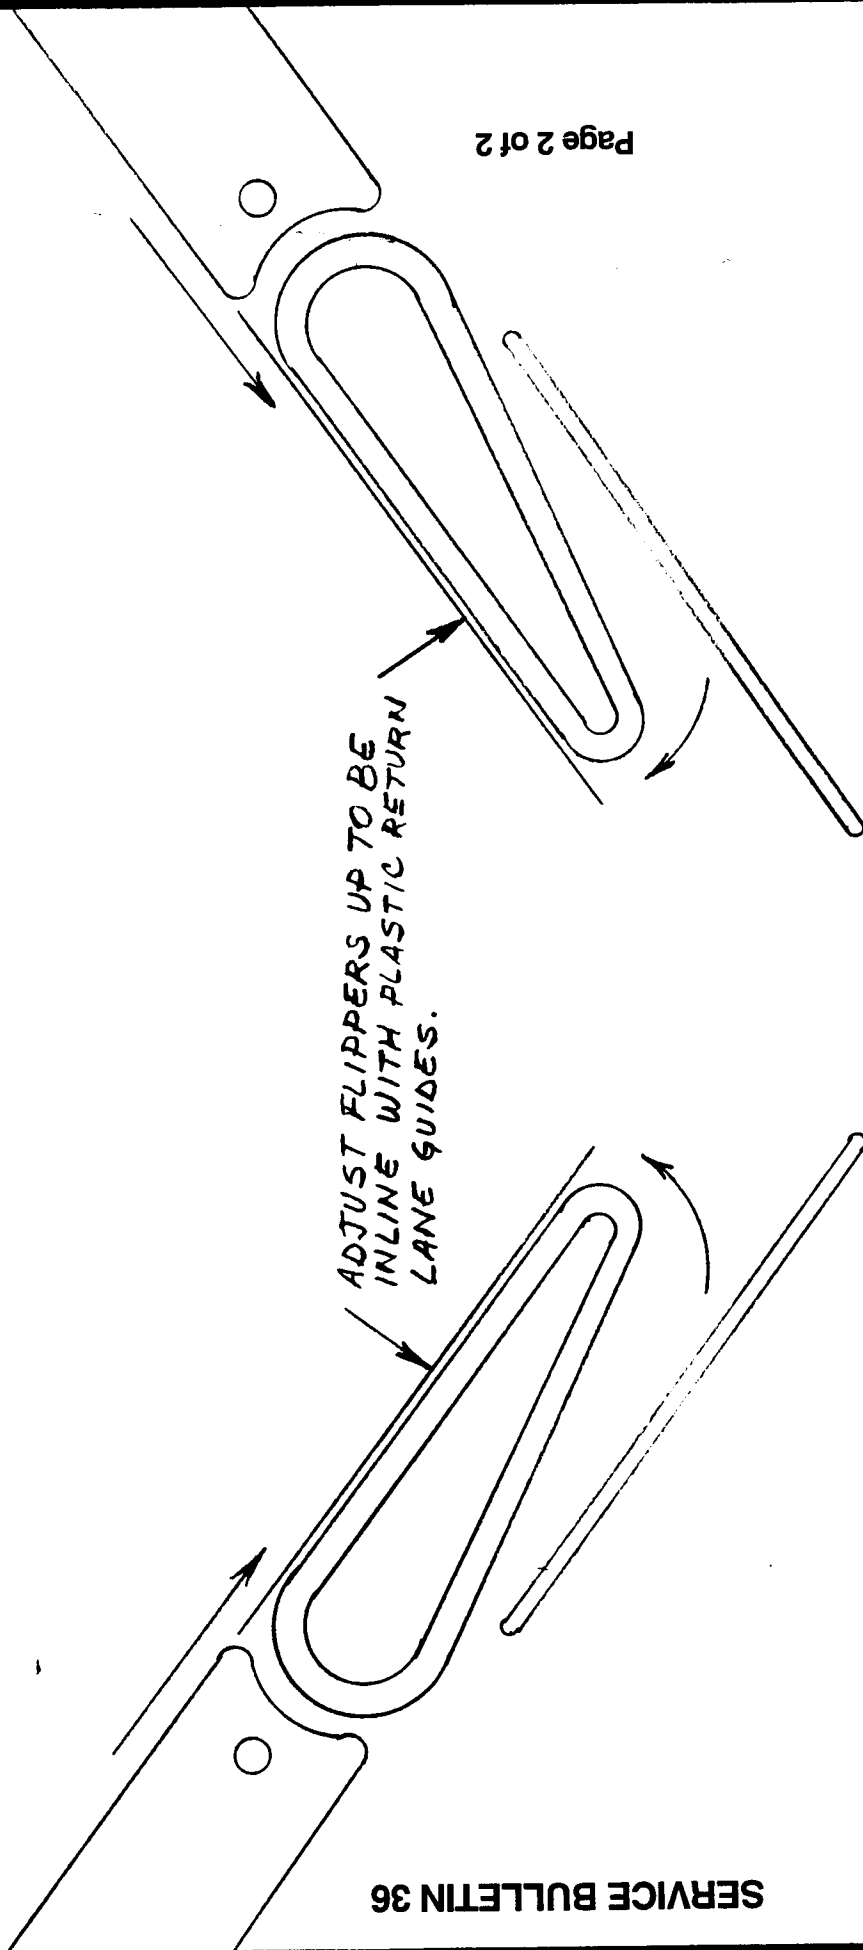
Symtom: The flippers appear weak on some Lethal Weapon 3 games, making it difficult to complete the ramp shot(s).

Cause: The flipper bat is not aligned properly with respect to the return lane guides. The bats are probably pointed too low, resulting in an inadequate striking angle on the ball.

*ADJUST FLIPPERS UP TO BE
INLINE WITH PLASTIC RETURN
LANE GUIDES.*

Solution: Loosen the socket head screw connecting the Plunger Link & Pawl Assembly to the bat and align each flipper with respect to the plastic return lane guides. (See attached drawing).
