## Service Bulletin No. 59

TO: Parts & Service Managers  
DATE: May 27, 1994  
RE: Servo Motor Stripping Gears on:

# TOMMY

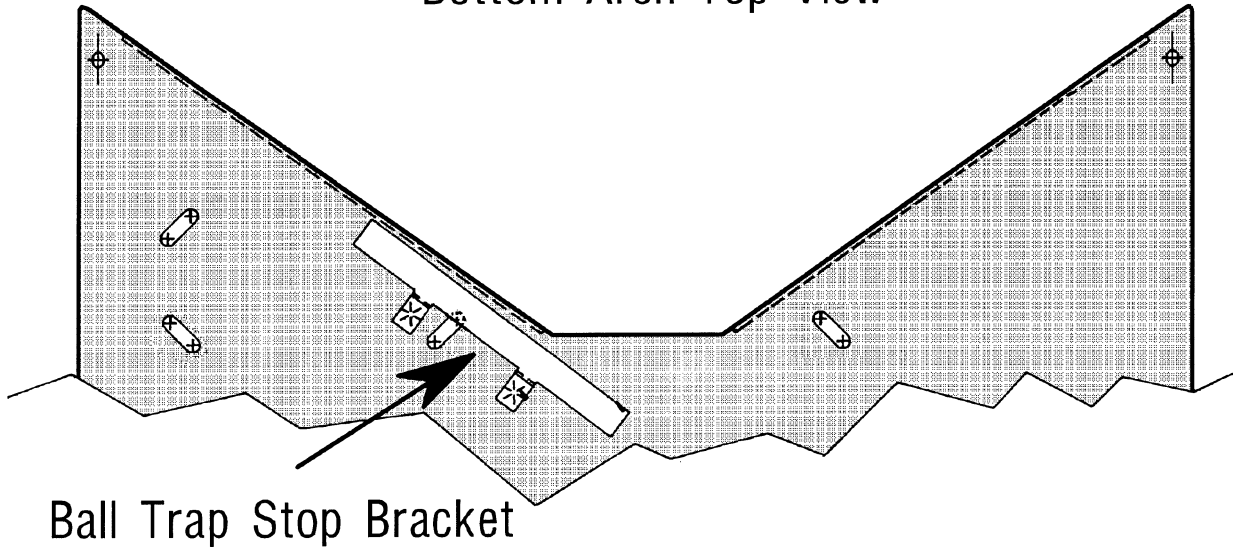
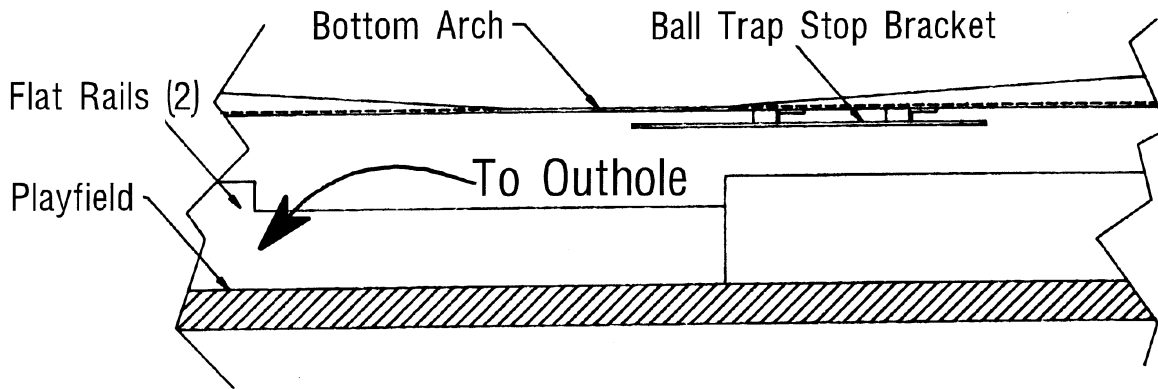
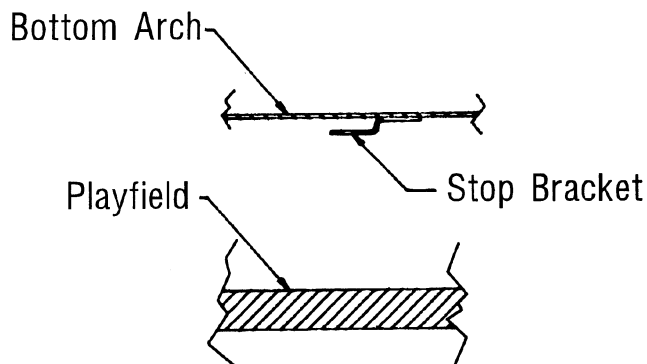
Fig. 01

**PROBLEM** The Link Arm and/or the left blinder (top) blade is getting stuck on the underside of the playfield arch. There is a metal strip (bracket) spot welded to the under side of the arch, which protrudes down to prevent ball traps (See Fig. 01). This metal strip (bracket) is getting bent, when the playfield is being lifted by the arch, and in some cases the metal strip (bracket) gets bent downward. In either case this could cause premature failure to the servo motor, if binding occurs.

Note: The Stop Bracket is parallel to playfield.

Inspect the underside of arch to ensure ball trap bracket is not bent. If bracket is bent adjust by re-bending the metal strip (bracket) according to the attached diagrams specifications. The specs. may vary depending on the particular arch assembly being used. The metal strip (bracket) should be parallel to the playfield with no bends.
