Service Bulletin N° 86

SUBJ: **INDEPENDENCE DAY** Potential Balltrap in the Plastic Under-Trough

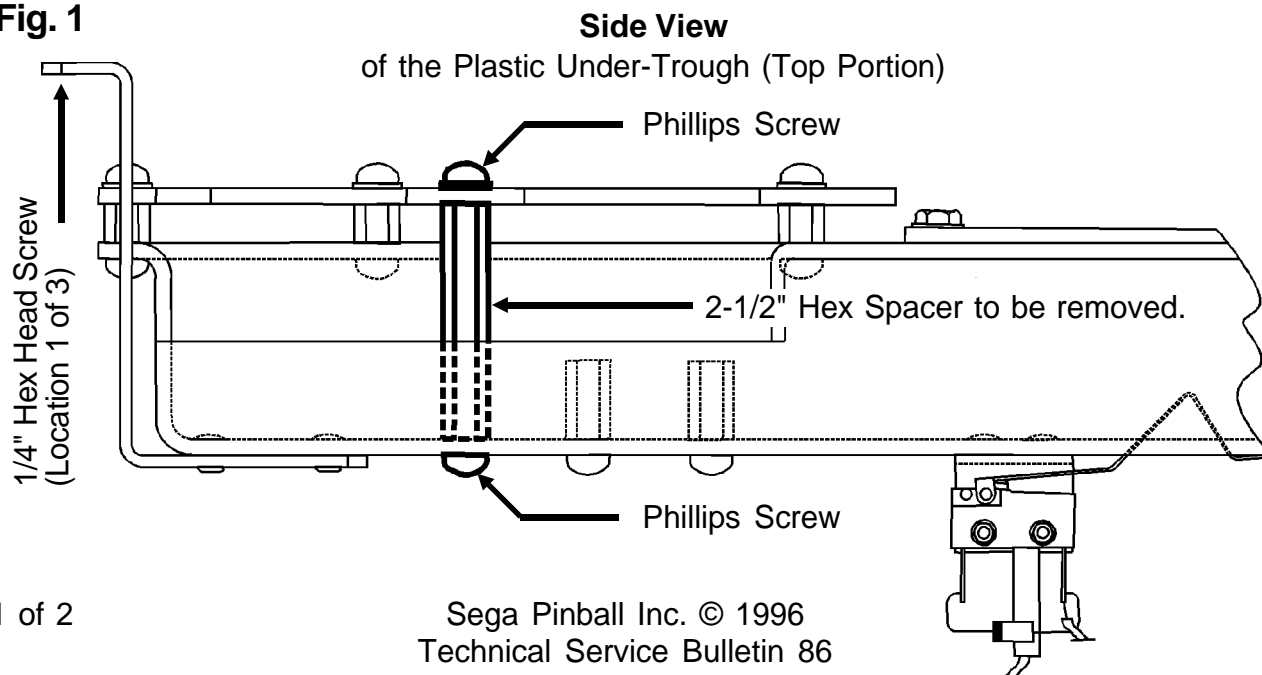
SYMPTOM: Balls get trapped in the Plastic Under-Trough Ramp beneath the *Alien Head*.

CAUSE: We have found a **potential** for a balltrap between the 2-1/2" Hex Spacer and the back wall of the Under-Trough because of normal variations in vacuum-formed plastic ramps (see Fig. 1 below).
