Service Bulletin N° 97

SUBJ: X-Wing Motor Bushing

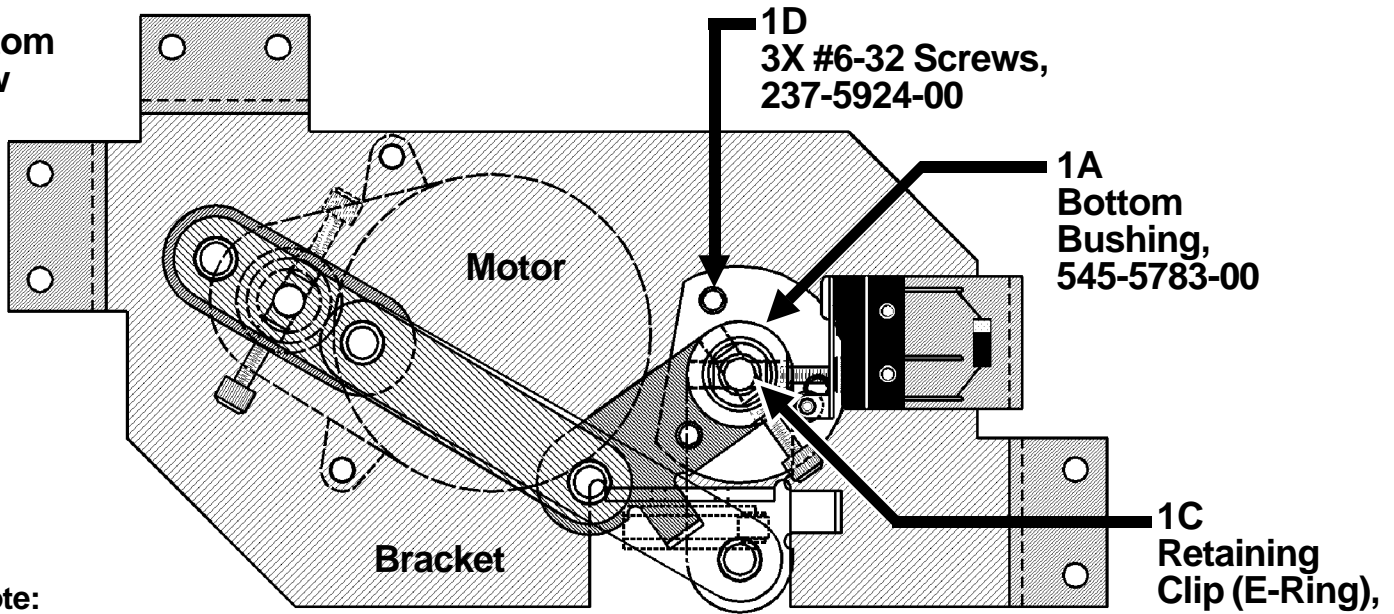
Bottom View

Sometimes at the start of the X-Wing Multiball Feature with the ball loaded into the Cannon, the X-Wing Assembly may not move. This does not necessarily mean the motor has failed; it is simply in a "stuck-state." The *slightest tap or nudge* to the game will start the X-Wing to move again. **If you should experience this symptom please refer to the procedure below.**

Due to slight variances in spotting the X-Wing Assembly while mounting it to the playfield, the shaft bushings (**See Fig. 1**) can cause some binding to the motor shaft. Increasing the inside diameter of *either* shaft bushing (**See Fig. 1A & 1B**) will correct this problem. For simplicity in this correction we recommend fixing the bottomshaft bushing (**See Fig. 1A**). (**See Note below.**)

If the Upper Bushing has a black stripe, you should not experience any "stuck-state" symptom and no further update procedure should be required.

- 1 Locate the X-Wing Motor Assembly Bottom Shaft Bushing, 545-5783-00, on the bottom side of the playfield (**See Fig. 1A**).
- 2 Locate and remove the Retaining Clip (E-Ring), 270-5002-00, located at the base of the X-Wing Shaft (**See Fig. 1C**).
- 3 Remove the three (3) #6-32 X 1/2" HWH TF Mounting Screws, 237-5924-00, securing the Bushing to the X-Wing Motor Bracket (**See Fig. 1D**).
- 4 Remove the Bushing from X-Wing Motor Bracket (**See Fig. 1A**). Using a #G or a 6.6mm Drill Bit, enlarge the existing Bushing Shaft Hole. Reassemble.

If you do experience the "stuck-state" symptom, simply remove the bottom shaft bushing (removal of the Retaining Ring & 3 Screws is required) and drill the existing Shaft Hole with a #G or 6.6mm Drill Bit and reassemble.

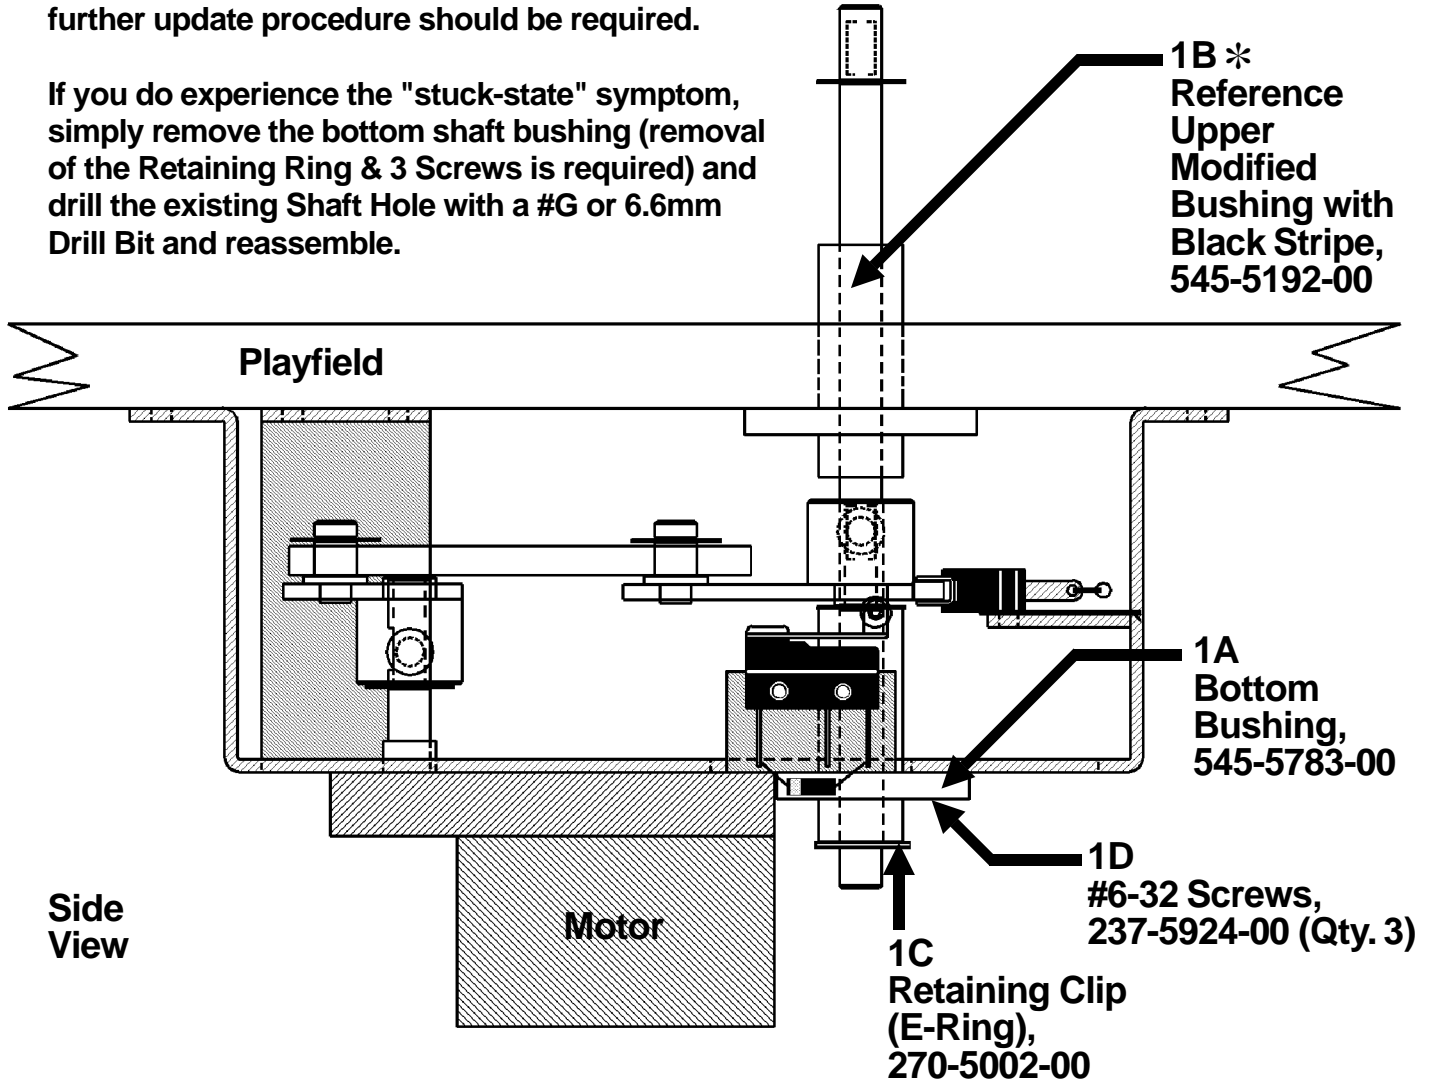
Side View

As stated, there are 2 X-Wing Shaft Bushings, one (1) on the X-Wing Motor Assembly (**See Fig. 1A**) and one (1) on the Upper Motor Shaft on the playfield side (**See Fig. 1B**). **All games made after Serial N° 138041 have been modified and should not experience this "stuck-state" symptom.** The bushing mounted on the playfield side will have a black stripe indicating this (**See Fig. 1B**). **Unless your game is experiencing the above symptoms disregard the above procedure.**
