**SERVICE BULLETIN 04
(Reprint)**

FROM: Pete Gustafson, Field Service Mgr.
TO: Service Managers
DATE: April 12, 1988
RE: Secret Service - Ball Trap

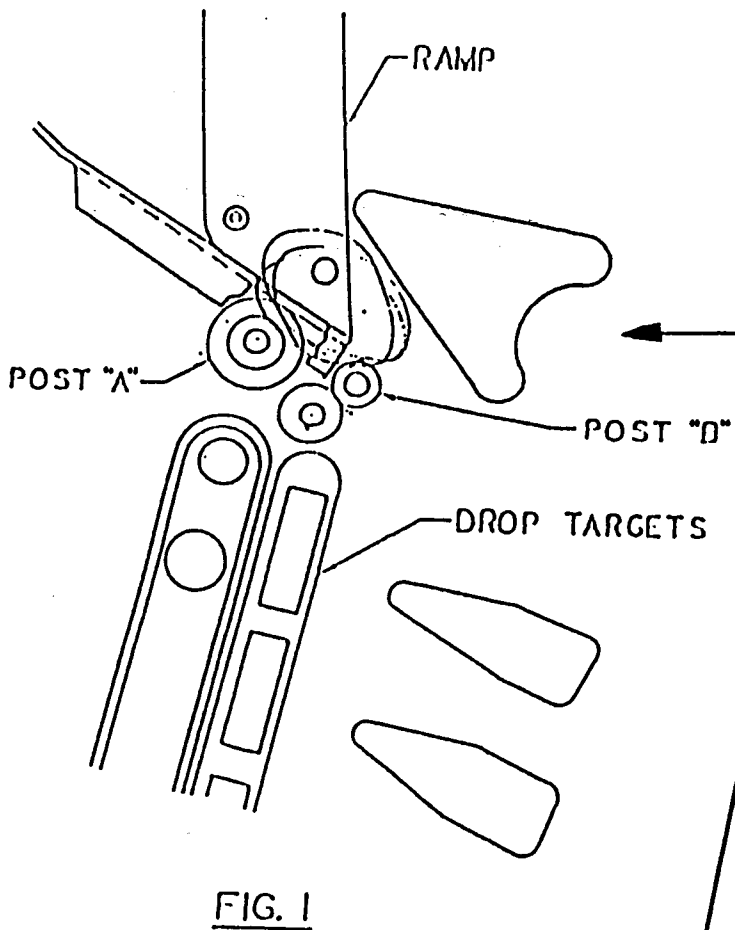
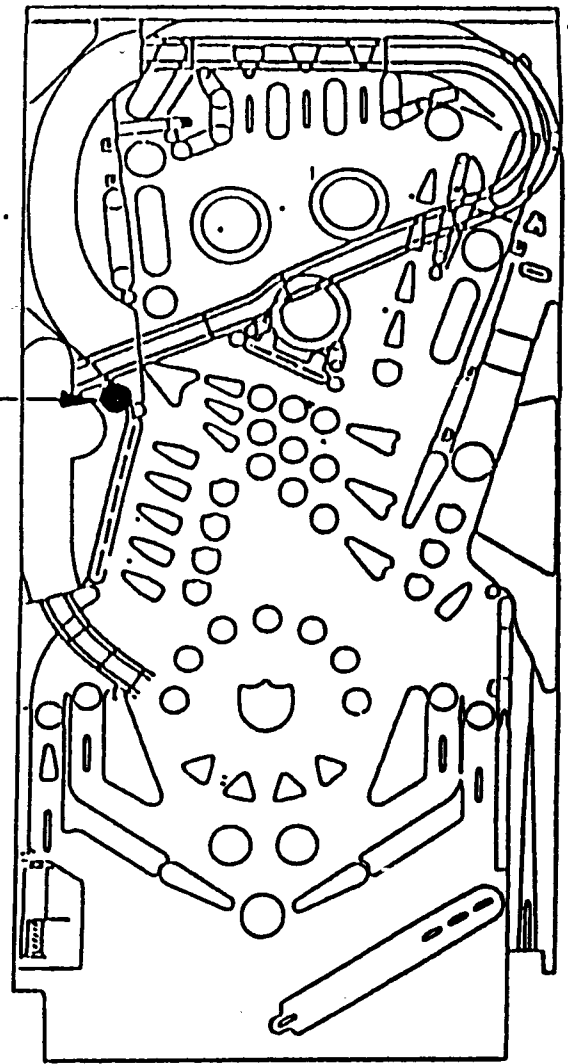
FIGURE 1

Symptom: Ball gets trapped on top of the post that is in front of the ramp, the screened plastic cover over the drop targets, and the side of the wire ramp going into the white house (see Fig. 1 & Fig. 2).

Two posts must be added to fully protect the left entrance wall of the ramp. The red plastic post should be placed behind the left wall, shown as post "A" in Fig. 1. This post prevents the wall from being flexed by ball pressure. The machine screw mini post must be placed in front of the left wall at the entrance shown as post "B" in Fig. 1. A 11/64" hole must be drilled for post "B."

1. Remove the acorn nut from the top of the post.
2. Using a heavy pair of side cutters, snip off the threaded portion of the post.
3. File any burrs off the post.

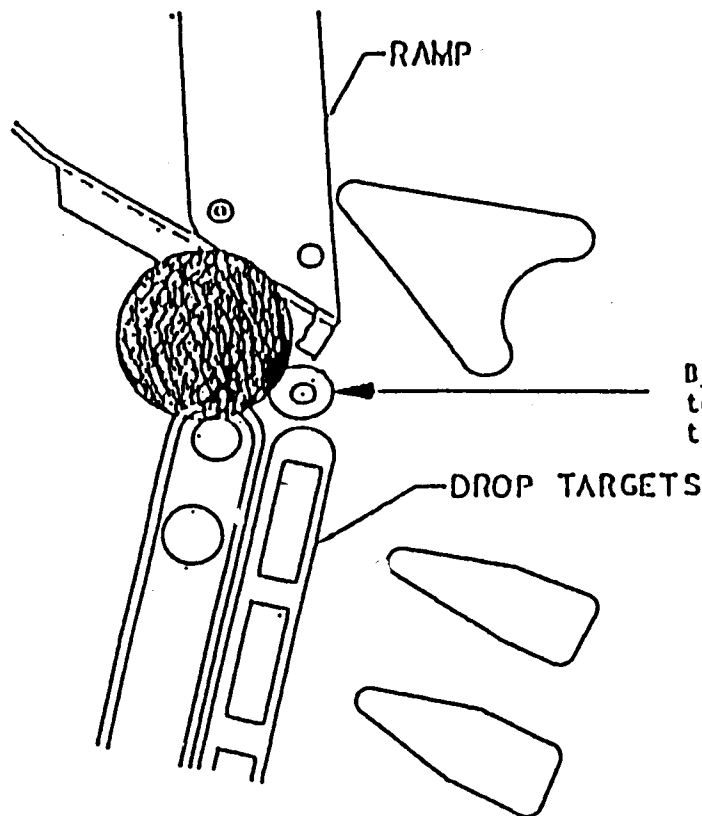
Problem: The post in front of the ramp is too tall.

By snipping off the top of this post, the ball will not be able to rest in the position shown.
