# Nº 124 SERVICE BULLETIN

SUBJ: Software Update: Replay Bug Fix for

Sharkeys Shootout & High Roller Casino

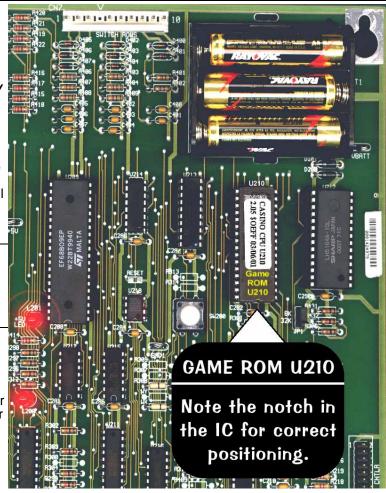
When replacing ROMs, use a proper flat tool to carefully remove the ROM. Make sure you are prying up the ROM AND NOT the IC SOCKET!!! When inserting the replacement ROM, ensure the Pins do not bend while inserting into the IC Socket. Note the position of the NOTCH. It should be in the same position as all the other ICs on the CPU Sound Board. U210 is located just under the batteries (Upper Right Corner) on your CPU/Sound Board, in the Backbox.
