TO: Service Managers  
FROM: Joe Blackwell  
DATE: November 12, 1993  
RE: Last Action Hero

Early production samples have exhibited an intermittent problem with the lock ball assembly (500-5684-01) . Listed below is the modification currently being used in production.

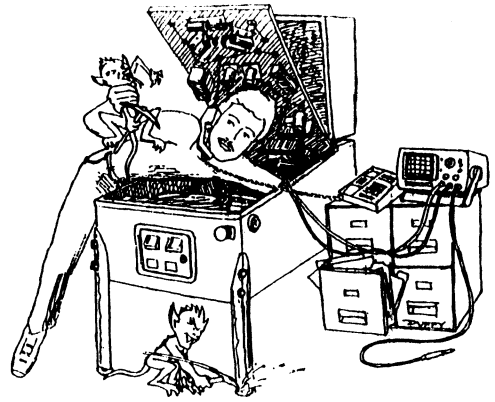
- Symptom: Balls are not being released from the six ball trough ass'y. Removing the arch assy. reveals balls are being jammed beneath the cam ass'y or the coil appears to have insufficient strength.
- Problem: The compression spring being used on the plunger ass'y is too heavy a gauge for this application.
- Solution: Replace with spring part number (266-5000-00) . This will reduce plunger resistance when the coil is activated.
- Note: If further assistance is required, please call Joe Blackwell at 1-800-542-5377 or 1-708-345-7700.
