DATA EAST PINBALL, INC.

To: Service Manager
 From: Data East Pinball Service Department
 Date: 2 April, 1993
 Subject: Service Advisory/Ball draining from right to left orbit shot on Rocky and Bullwinkle.

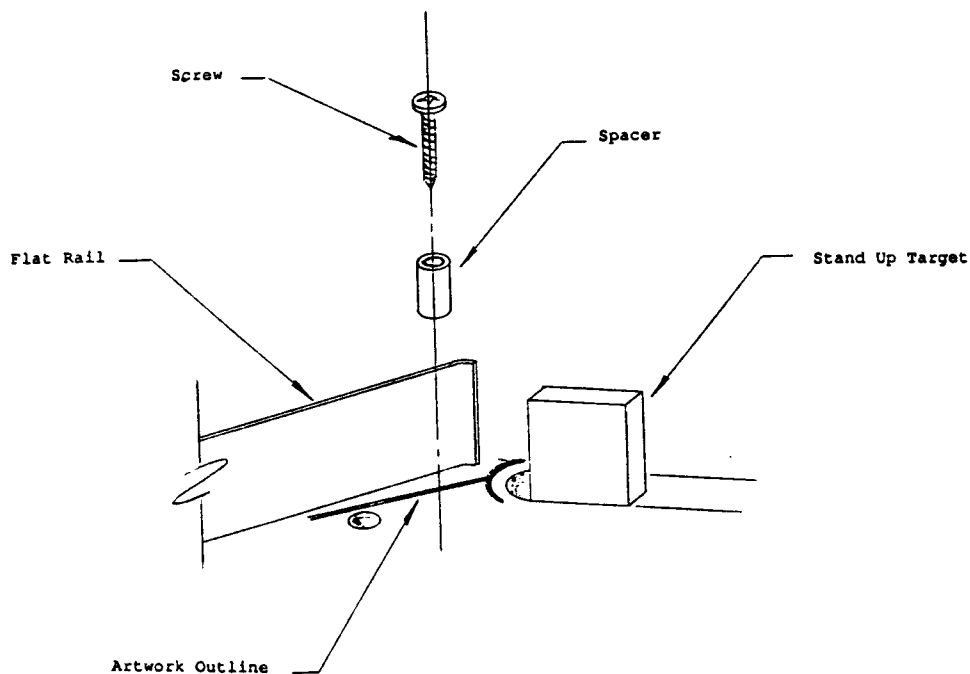
Symptom- Shooting the ball, using the left flipper to accomplish the right to left orbit shot, results in the ball exiting the playfield between the 2 Flippers.

Cause-The left flat rail may not remain properly aligned with the artwork due to the elasticity of the material and an insufficient number of support brackets on the side rail.

Remedy- Using the attached drawing as a guide, secure a small post with a #8x1" machine screw behind the left side of the flat rail. This is the area right above the Hat Trick Standup Targets. Before tightening the screw make sure the flat rail is properly aligned with the artwork.
